# Studebaker

# Service Letter

**SUBJECT** WATER IN THE TAIL LAMP HOUSING  
1964 STUDEBAKER MODELS - EXCEPT  
STATION WAGONS

**NUMBER** F-1964-5

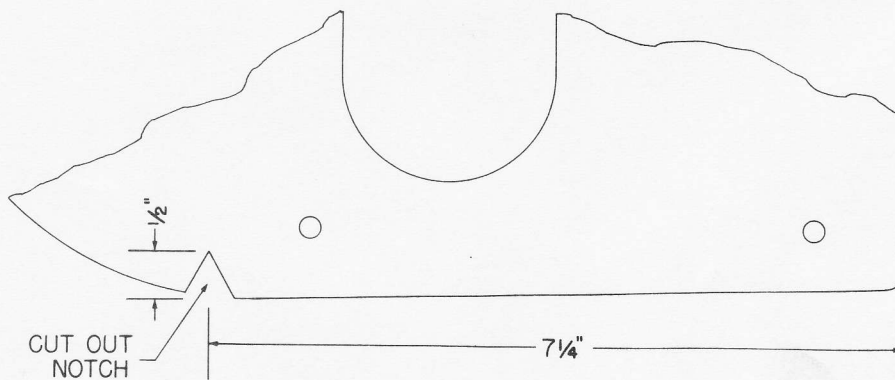
There is a possibility that water may enter the tail light housing on some 1964 model passenger cars (except station wagons) and result in an inoperative tail light. There are two probable causes for this condition.

1. Improper sealing of the lens to lamp housing.
2. Improper sealing of lamp housing to the rear fender.

1. Place the lamp assembly face downward in a container having approximately two inches of water in it and note any points of leakage. Should leakage into the lamp assembly be noted it will be necessary to install a new Tail Lamp Lens Gasket, Part Number 1356262.
2. Modify the tail lamp to body gasket as shown in the illustration and install the tail light assembly.
