SUBJECT MISALIGNMENT OF FRONT SEAT BACKS ON
MODELS EQUIPPED WITH RECLINING SEATS

NUMBER F-1966-3

FROM C. R. MC INTOSH, Manager
Technical Service Operations

DATE Dec. 13, 1965

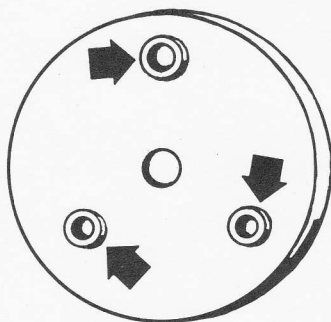
Fig. 1

You may occasionally encounter a condition where the front seat backs of cars equipped with reclining seats are not aligned in fore and aft position. Investigation of such a condition indicates the misalignment to be generally caused by improper mounting of the adjusting mechanism internal gear housing on the seat frame. The condition can be corrected by the following procedure:

1. Remove the reclining seat back control, as outlined on page 8, Body Section, Group V of the 1962-64 Passenger Car Shop Manual.
2. The mounting holes in seat frame for internal gear housing are drilled to close tolerances. Remove any burrs that might have occurred due to previous misalignment. Also check mounting lugs (See Fig. 1) on back of internal gear housing for distortion or burrs. Correct as required.
3. Place internal gear housing on seat frame. Make sure mounting lugs squarely enter seat frame holes and install retaining bolts.
4. Tighten retaining bolts progressively to maintain alignment. The two smaller bolts should be tightened to 3-4 ft. torque; the larger bolt to 8-9 lbs. ft. torque.
5. Reassemble control mechanism as outlined in the shop manual. Be sure to use the correct control lever spring and to install the spring (3) as shown in Figure 2.
