**Studebaker**

**Service Letter**

WHEEL DISC ANTI-CREEP RETAINER  
SUBJECT -- 1964 MODEL PASSENGER CARS

NUMBER C-1964-1

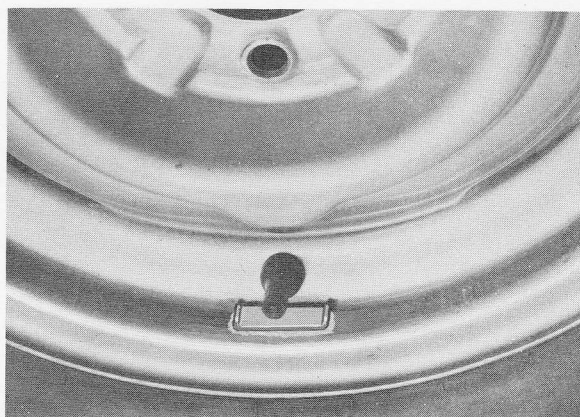
Some wheels used on 1964 model passenger cars produced in Canada do not have a wheel disc (hub cap) anti-creep tab. As a result, under certain operating conditions, the wheel disc may creep and damage the tire valve stem.

1. Position the retainer on the wheel so it is equal distance on each side of the valve stem hole and approximately  $11/32$ " back from the vertical edge of the wheel rim (see illustration). Mark around the outside of the retainer and remove from the wheel.
2. Clean the paint from the wheel within the marked area.
3. Apply Epoxy Cement to the cleaned area of the wheel and on the retainer. (Follow manufacturer's instructions in the use of the cement.)
4. Install the retainer in position and permit the cement to dry thoroughly.
5. Install the wheel disc.

Whenever you encounter this condition, it can be corrected by the installation of a Wheel Cover Retainer, Part No. 1564199. The retainer is attached to each wheel by cementing into position, using Epoxy Cement, which is available from hardware stores.
